INDOOR AIR QUALITY ASSESSMENT

**Gerena Magnet School
200 Birnie Street
Springfield, Massachusetts**

Prepared by:
Massachusetts Department of Public Health
Center for Environmental Health
Bureau of Environmental Health Assessment
July 2004

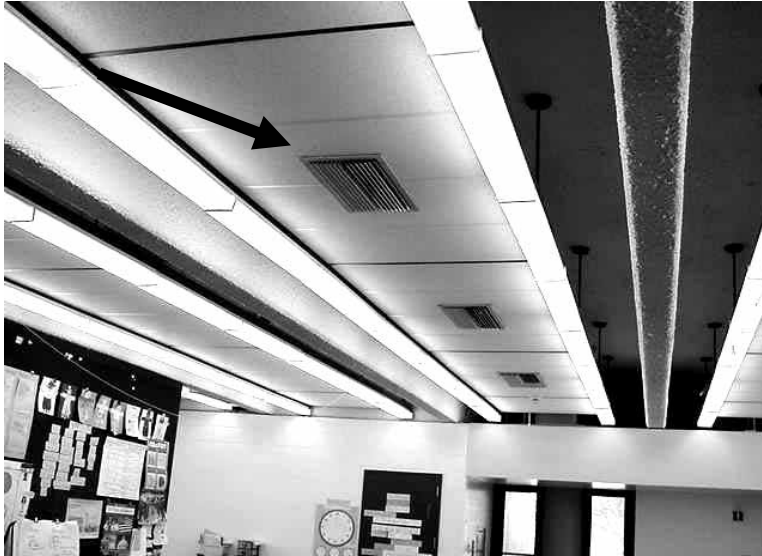
Picture 3

Ceiling Mounted Fresh Air Supply

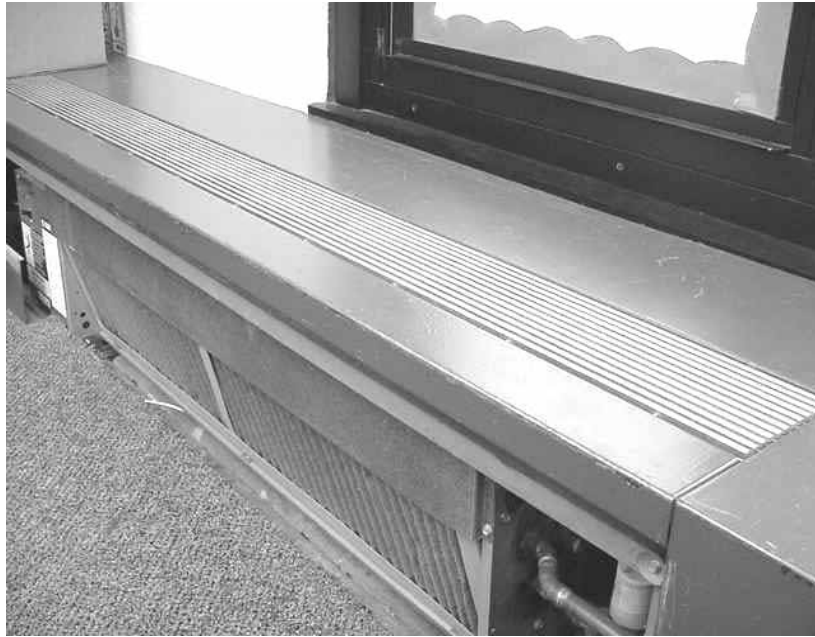
Picture 4

Unit ventilator systems (univents) supply fresh air to small classroom areas, or minipods (Picture 4) (Table 1). Univents draw air from outdoors through a fresh air intake located on the exterior walls of the building and return air through an air intake located at the base of each unit ([Figure 1](#)). Fresh and return air are mixed, filtered, heated and provided to classrooms through an air diffuser located in the top of the unit. Univents have three controls: low, high and off. Univents were turned off in classrooms throughout the school. In order for univents to provide fresh air as designed, these units must remain “on” and allowed to operate while rooms are occupied. Furthermore, intakes must remain free of obstructions.

Minipod Univent (With Front Cover Removed By BEHA Staff)

- 5) Remove all blockages from univents to ensure adequate airflow.
- 6) Consider the following actions to prevent moisture penetration into the building:

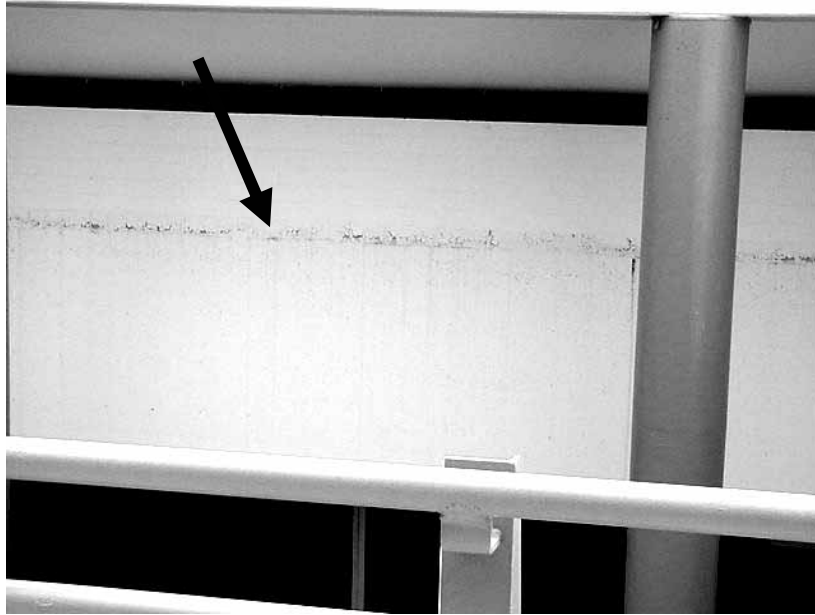
Picture 5

A letter detailing possible mold contamination identified in classrooms in the GMS and Annex was issued by BEHA prior to this report (Appendix B) (MDPH, 2004). Of note is water penetration in below grade areas, directly beneath the footprint of the school. The rear wall of the atrium showed signs of efflorescence and peeling paint (Picture 5), which indicate water penetration. Efflorescence is a characteristic sign of water damage to brick and mortar, but it is not mold growth. Brick, cement and mortar are not generally good mold growth media. As moisture penetrates and works its way through mortar and brick, water-soluble compounds in brick and mortar dissolve, creating a solution. As the solution

moves to the surface of brick or mortar, the water evaporates, leaving behind white, powdery mineral deposits.

Rear Wall of the Atrium with Efflorescence and Peeling Paint

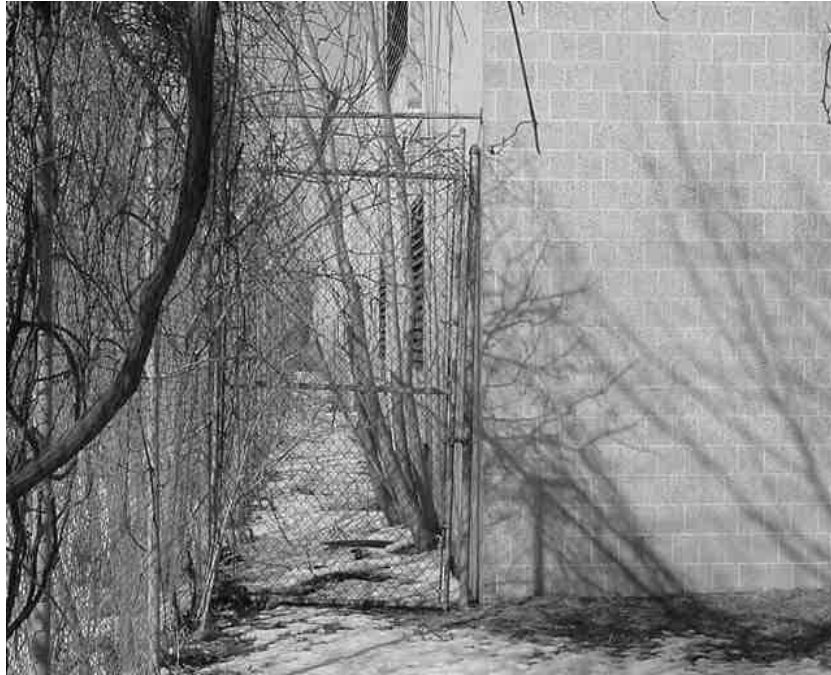
Picture 6

The grounds around the GMS building exterior may also provide a source of moisture. Railroad tracks parallel the rear of the school. A chain link fence separates the tracks and the building (Picture 6). Trees, weeds, and standing water were seen in the gap between the building and the tracks. The growth of roots against exterior walls can bring moisture in contact with the walls, which can eventually lead to cracks and/or fissures in the foundation below ground level. Over time, this process can undermine the integrity of the building envelope and provide a means of water entry into the building through foundation concrete and masonry via capillary action (Lstiburek & Brennan, 2001).

**The Area between the Chain Link Fence, Tracks and the Rear Exterior Wall
Containing Trees, Weeds and Standing Water**

- a) Remove foliage to no less than five feet from the foundation.
 - b) Improve the grading of the ground away from the foundation at a rate of 6 inches per every 10 feet (Lstiburek & Brennan, 2001).

- c) Install a water impermeable layer (e.g. clay cap) on ground surface to prevent water saturation of ground near foundation (Lstiburek & Brennan, 2001).
